JANUARY 1980 THE NAVAL AVIATION SAFETY REVIEW

approach

NAVAIR 00-75-510

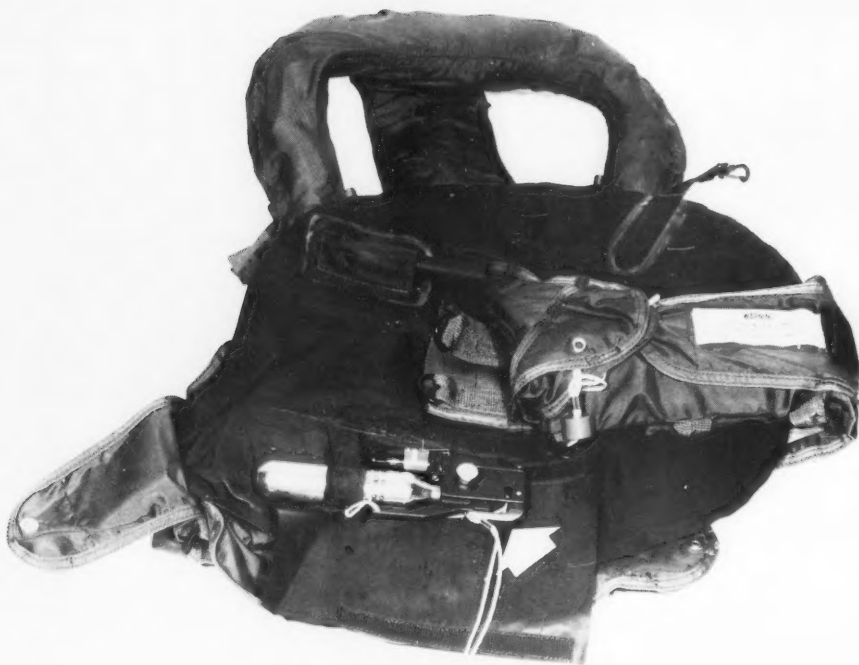
FLU-8/P automatic inflation actuating device.

The APPROACH article, "Survival: Some Solutions" (NOV '78), introduced the automatic inflator, detailed the design requirements, and outlined the testing required. For further amplification, the automatic inflation device (FLU-8/P) is a one-time, one-shot, cartridge-actuated device which replaces the present manual-actuating device to provide inflation of the LPA assembly upon immersion in water. The FLU-8/P will be provided to crewmembers of ejection seat aircraft only, and will function procedurally as a backup to the manual actuation mode. Due to the high priority established for this program, OPNAV, contrary to established procedure, authorized the procurement of production devices prior to receiving approval for service use; therefore, at the completion of approval for service use, automatic inflation devices will be immediately available to the Fleet. The initial authorized configuration for the FLU-8/P will be with the 28-gram CO₂ bottle. Initial Fleet outfitting will be accomplished through issuance of ACC 398. ACC 398 consists of instructions for the modification of the LPA casing to accept the

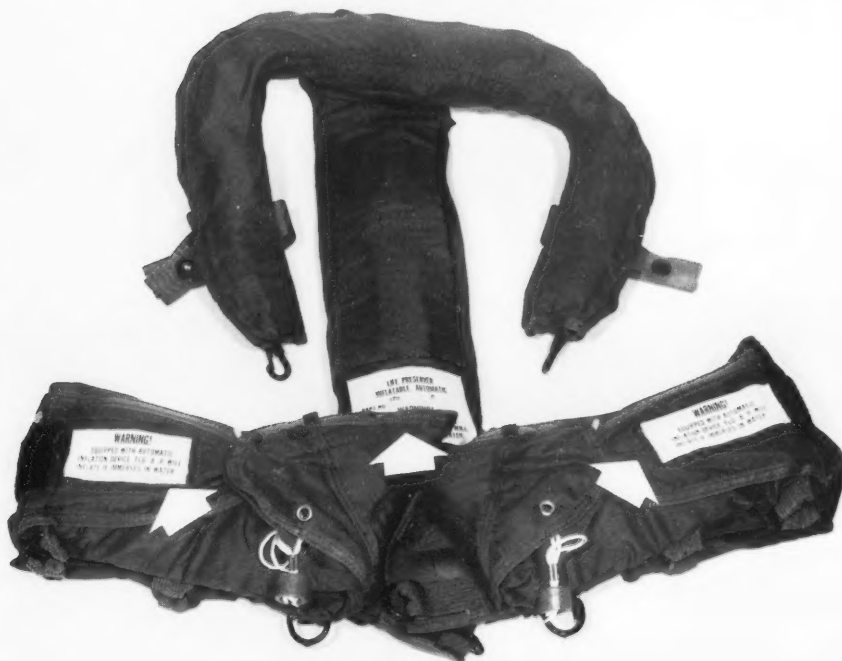
Note warning labels indicating installation of FLU-8/P device.

A Note of Caution: LPAs equipped with the FLU-8/P automatic inflator shall be worn only in ejection seat aircraft. In the event of a ditching in a nonejection seat aircraft, inflation upon water immersion could preclude aircraft egress. TACAIR pilots riding as passengers in nonejection seat aircraft must use the appropriate passenger life preserver for that aircraft. Crewmembers in nonejection seat aircraft carrying passengers shall ensure that no passenger is wearing an LPA with the FLU-8/P installed. (LPAs incorporating the FLU-8/P will have warning labels sewn to each waist lobe and to the collar lobe). —Ed.
